Home Inspection Report

32936 Shephard Court, Winchester

**Christopher Benne
October 29, 2018**

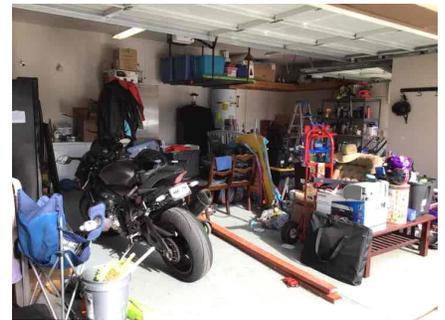
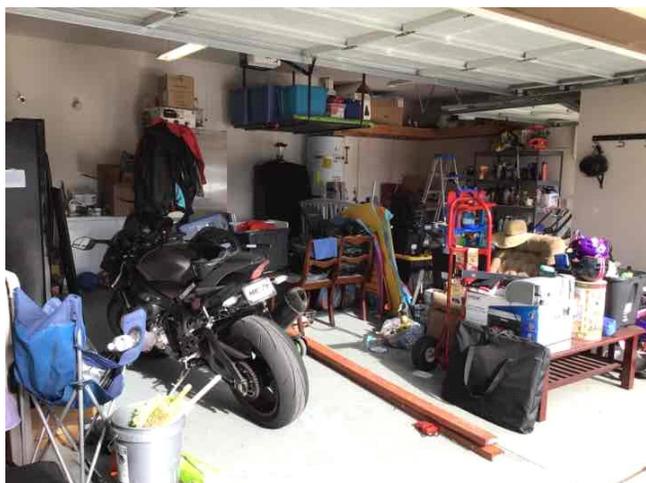
Photo 03

Personal storage was blocking access to the interior of the garage. Therefore, the area is considered inaccessible and was not fully inspected. With access and an opportunity for complete inspection, conditions in need of attention may be discovered. Ideally, the personal belongings should be removed so the area may be inspected. (See Photo 3)

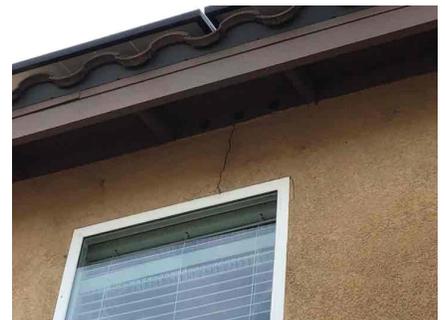
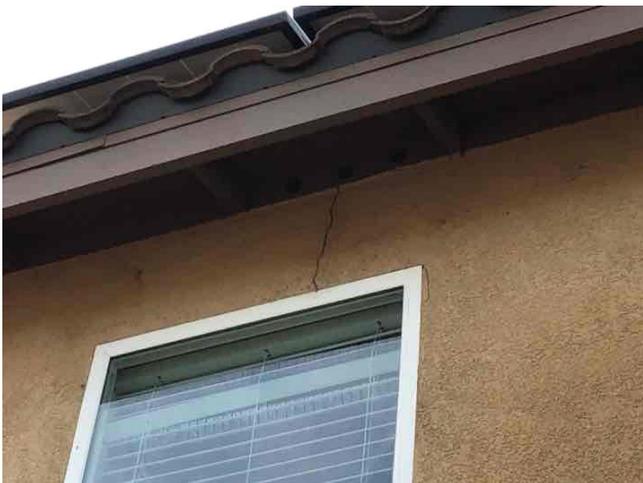
Photo 11

- ! 1. There are moderate sized cracks in the exterior stucco that should be patched and sealed as part of preparation for the next painting. Flexible patching materials are recommended rather than rigid patching compounds. (See Photo 11)

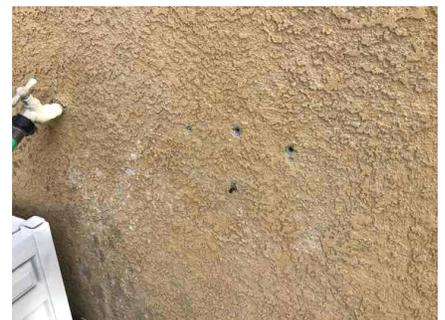
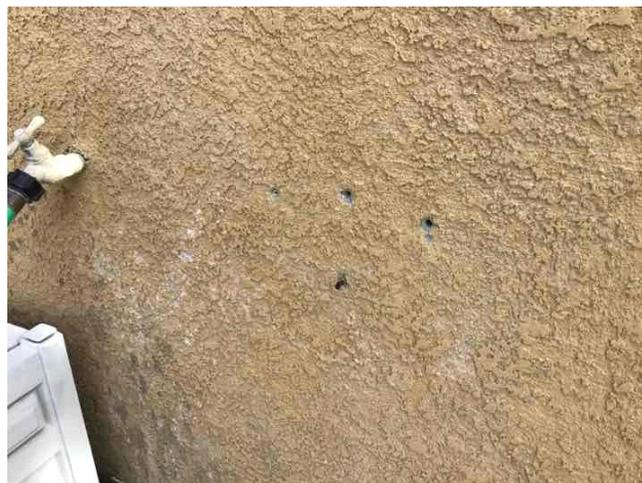
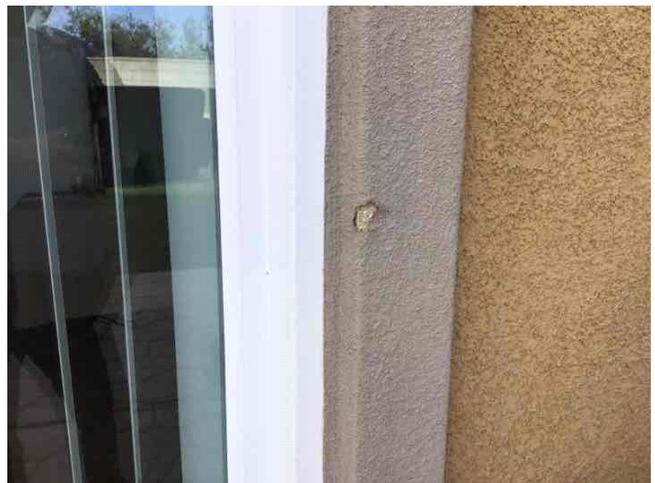
Photo 02

- ! 2. There is small openings or holes in the stucco at various areas. We recommend this area be repaired or replaced to eliminate moisture or rodent entry. (See Photo 2) (See Photo 12)

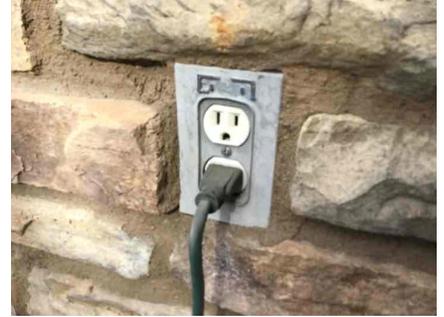
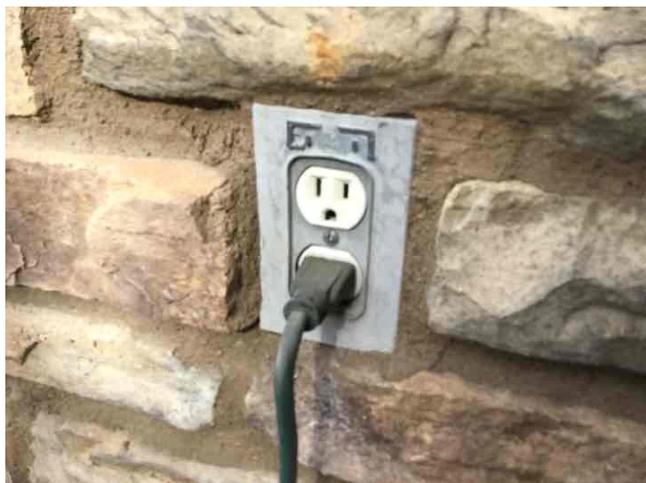
Photo 01

4. Exterior receptacles at the front are missing a water proof cover plate. We recommend a exterior approved cover be installed. (See Photo 1)

- ! 1. Exterior receptacles at the front are missing a water proof cover plate. We recommend a exterior approved cover be installed. (See Photo 1)
2. The missing outlet cover plates at the upstairs left bedroom should be replaced. Based upon our inspection of a representative number of outlets we recommend checking every outlet to make sure they all have covers.
3. One or more of the electrical panel circuit breakers were noted to be turned off at the time of our inspection. The breakers do not appear to be tripped and the exact reason for them being turned off was not determined during this inspection. For additional information we recommend consultation with the owner or a licensed electrical contractor.

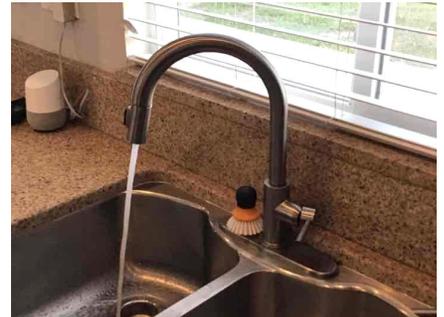
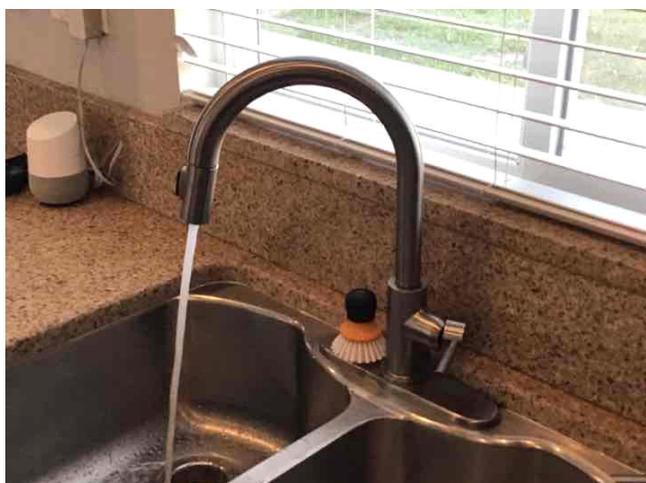
Photo 05

5. The kitchen sink faucet hot and cold water controls are reversed. Reversed hot and cold water can result in hot water burns. We recommend that this condition be corrected. (See Photo 5)

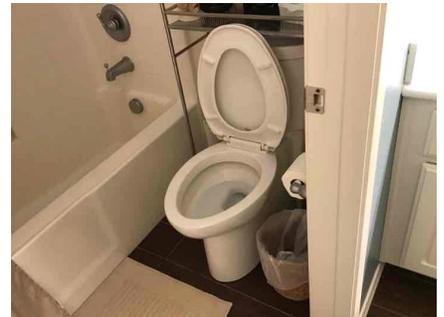
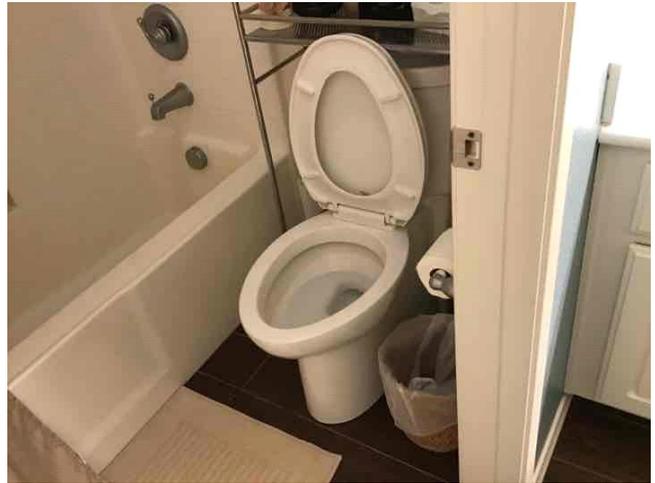
Photo 08

6. The toilet at the upstairs hall bathroom is loose and should be properly re-secured, tightened and caulked. (See Illustration 8J) (See Photo 8)

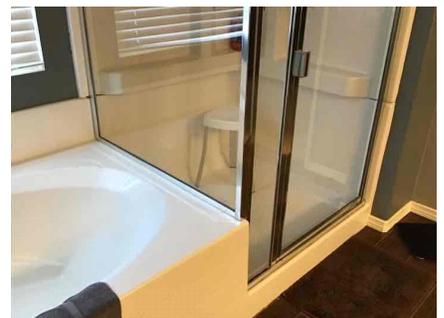
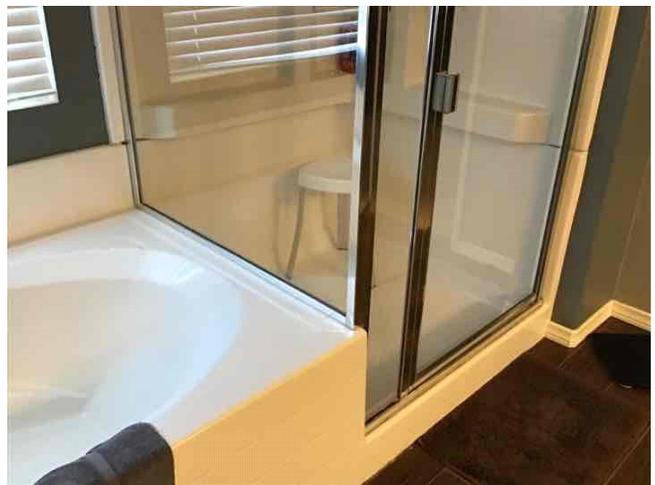
Photo 10

7. Cracked, deteriorated and/or missing tub/shower enclosure caulk in the master bathroom should be replaced. Water leaking through non-sealed areas can cause damage. Damage caused by water seepage cannot be determined by this visual observation. (See Photo 10)

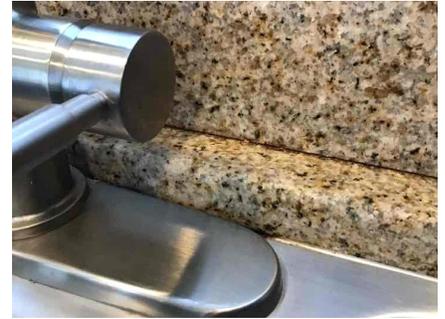
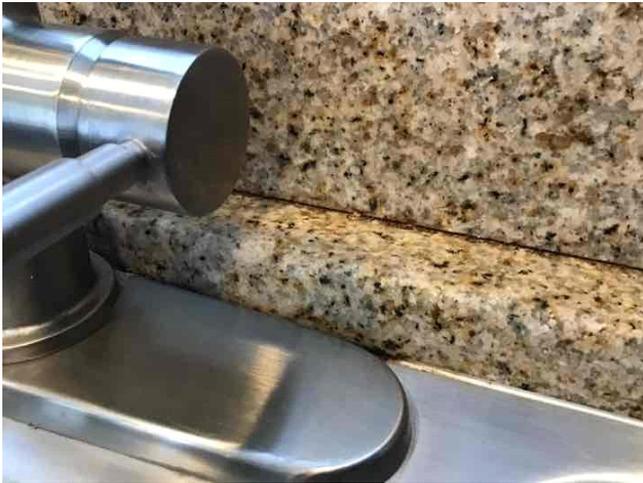
Photo 07

8. Cracked, deteriorated and/or missing caulk and grout at the kitchen countertop and/or backsplash should be replaced. A flexible caulking material is recommended. (See Photo 7)

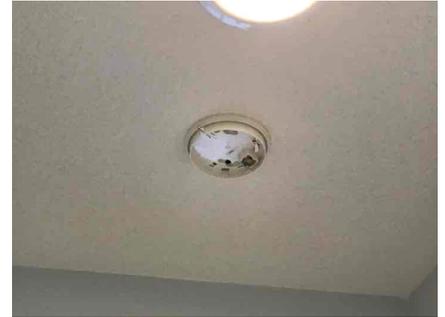
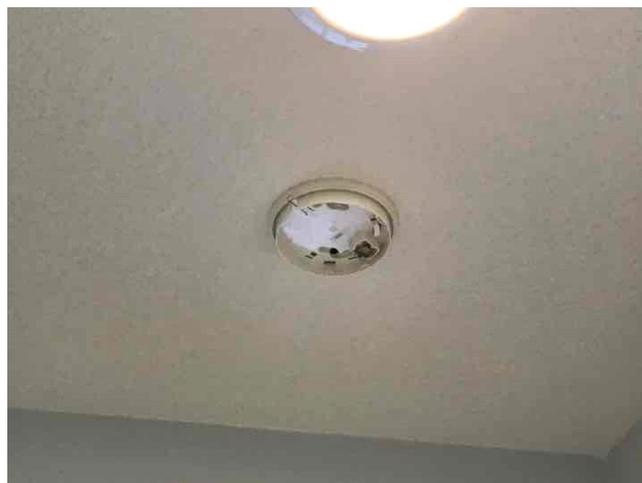
Photo 04

9. The installation of smoke detector was missing or removed at the downstairs kitchen hall is required for added safety. (See Photo 4)

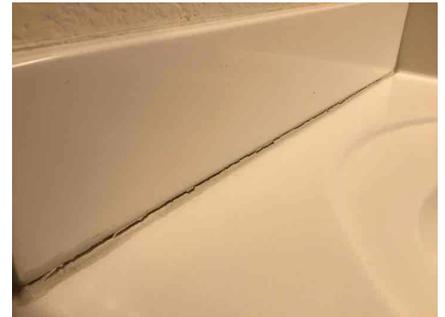
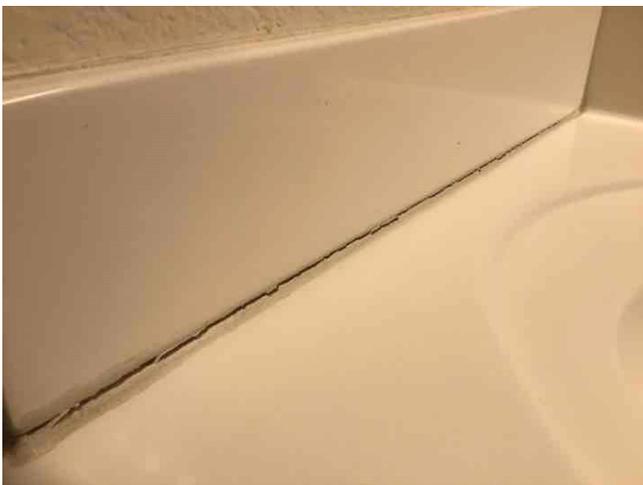
Photo 09

10. Cracked, deteriorated and/or missing caulk at the upstairs hall bathroom countertop backsplash should be replaced. A flexible caulking material is recommended rather than rigid cementitious grout. (See Photo 9)

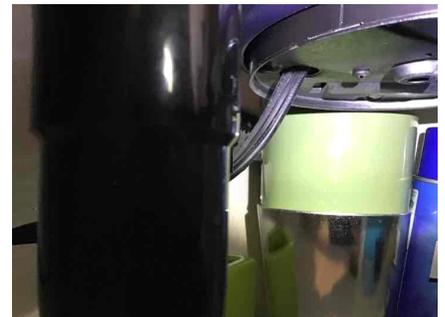
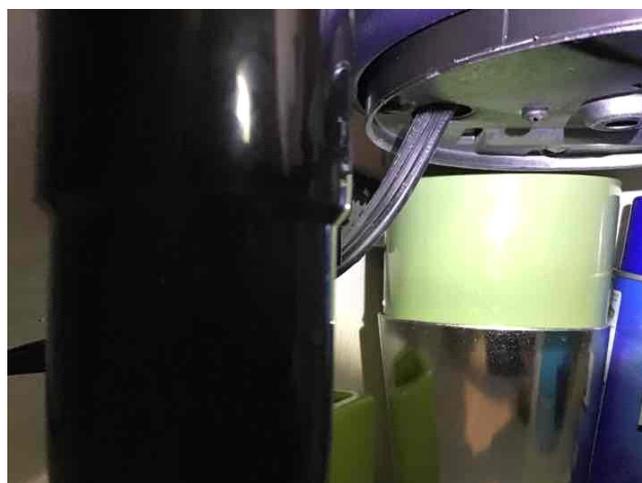
Photo 06

11. The power cord is not secured where it enters the bottom of the disposal and can be easily damaged. For maximum safety, we recommend the power cord be properly connected to the disposal. (See Illustration 9H) (See Photo 6)

- ! 1. The power cord is not secured where it enters the bottom of the disposal and can be easily damaged. For maximum safety, we recommend the power cord be properly connected to the disposal. (See Illustration 9H) (See Photo 6)
