Home Inspection Report

32936 Shephard Court, Winchester

**Christopher Benne
October 29, 2018**

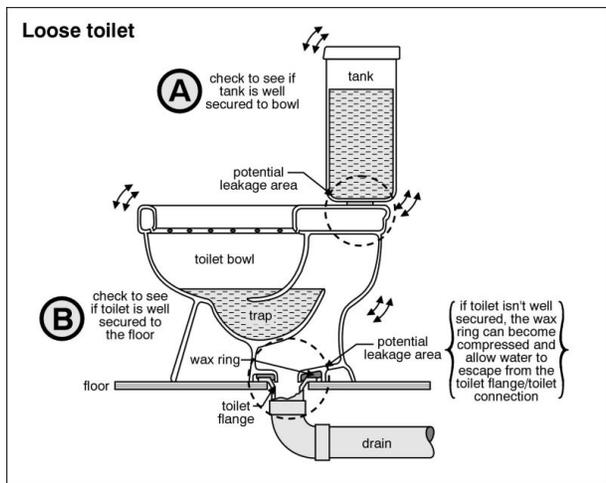
Illustration 8J

6. The toilet at the upstairs hall bathroom is loose and should be properly re-secured, tightened and caulked. (See Illustration 8J) (See Photo 8)

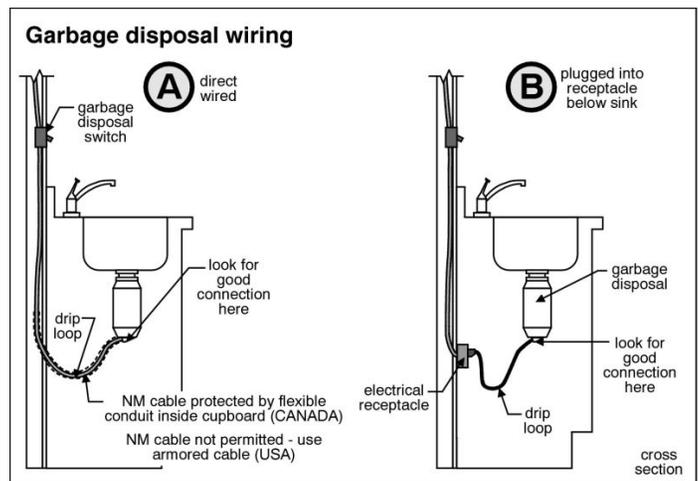
Illustration 9H

11. The power cord is not secured where it enters the bottom of the disposal and can be easily damaged. For maximum safety, we recommend the power cord be properly connected to the disposal. (See Illustration 9H) (See Photo 6)
